EFFECT OF TIG REMELTING ON PROPERTIES AND STRUCTURE OF WELDED JOINTS OF AUSTENITIC STAINLESS STEEL

Cyprian Tyszko¹, Jacek Górka²

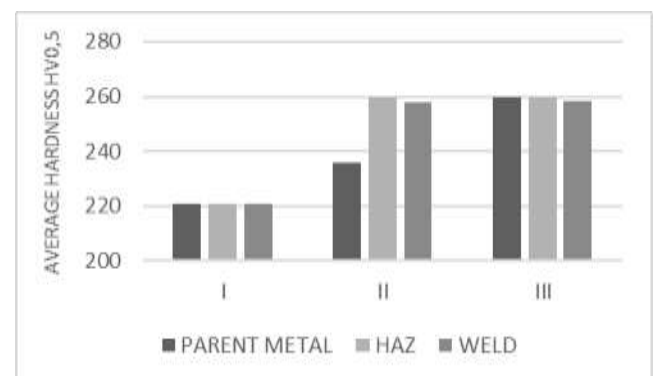
Fig. 12. Comparison of the average hardness of individual test joints (with division into weld zones).

As a result of tests of hardness using the Vickers HV0.5 method, it was found that the hardness of the test joint not subjected to remelting (I), in each zone is within the values declared by major manufacturers for steel AISI 304. In the case of remelted joints, each zone hardened in comparison to the parent metal, but

the hardness in the remelted joint without maintaining the interpass temperature (III), the hardness increased the most (it was about 30 HV0.5 more than the maximum declared values for the tested steel).

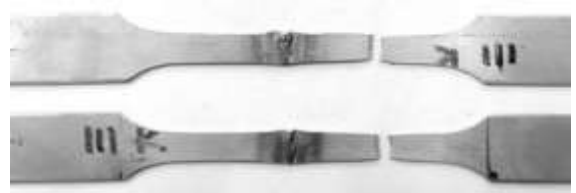
Fig. 18. Samples of joint III after static tensile test.

The carried out static tensile test showed that the tensile strength of all the samples was within the range 625-628 MPa, which indicates a negligible

effect of remelting on this parameter. The breaking of each sample occurred in the region of the native material. The remelting noticeably worsened the elongation of the samples, but the elongation values for each of the joints were within the range defined in EN 10088-2 standard [12]. Results of mechanical examinations are shown in Table 8.

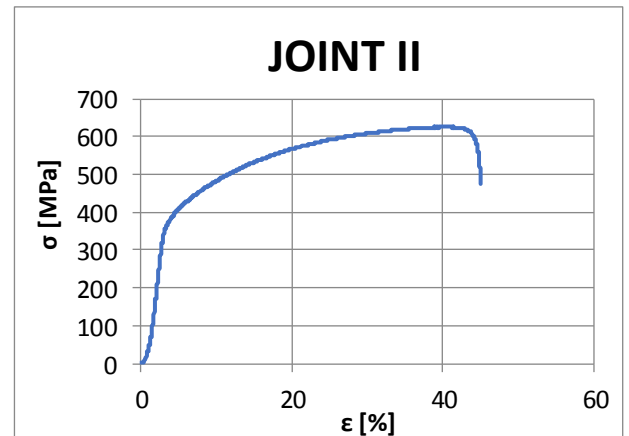
Fig. 20. Stress - strain curve for joint II.

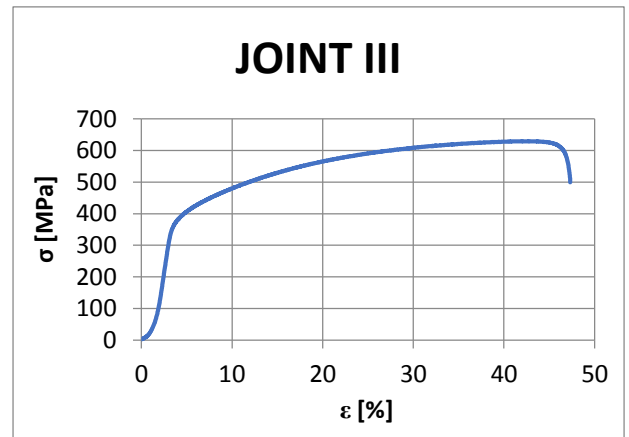
Fig. 21. Stress - strain curve for joint III.

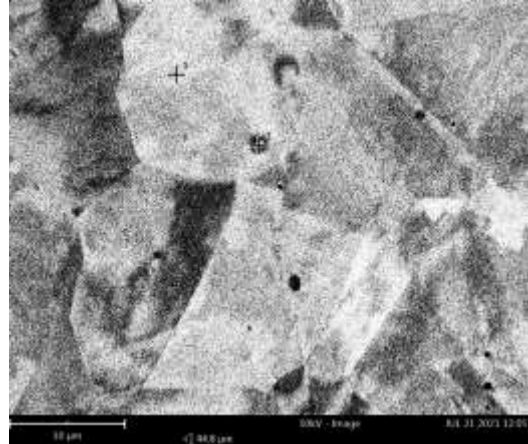
Fig. 23. SEM image of microstructure of the HAZ of single-welded non-melted joint (I).

Point	Fe [% Wt.]	Cr [% Wt.]	Ni [% Wt.]	C [% Wt.]
1 (Figure 23)	75.18	16.82	7.99	-
2 (Figure 23)	71.13	18.23	10.64	-
1 (Figure 24)	73.88	17.50	8.61	-
2 (Figure 24)	70.69	21.56	-	7.21
1 (Figure 25)	70.46	18.66	10.88	-
2 (Figure 25)	72.34	23.82	3.84	-

Based on a Figure 22, it was determined that the parent material had a fully austenitic structure. The HAZ of single-welded non-melted joint (I), which was shown in Figure 23 and 24, had an austenitic structure with point-like precipitates of chromium carbides at the austenite-ferrite boundaries (Point 2 – Figure 24) and presence of high-temperature δ -ferrite (Point 2 – Figure 23). The weld of single-welded non-melted joint (Figure 25) had a structure similar to the HAZ, except that additionally it was observed the occurrence of a σ -phase characterized by a high chromium and a low nickel content (Point 2 – Figure 25).
